DEPARTMENT OF TRANSPORTATION

Quality Assurance and Source Inspection

Contract #: 04-0120F4Cty: SF/ALA Rte: 80 PM: 13.2/13.9File #: 69.28**WELDING INSPECTION REPORT****Resident Engineer:**Pursell, Gary**Address:** 333 Burma Road**City:** Oakland, CA 94607**Report No:** WIR-003035**Date Inspected:** 23-Jun-2008**Project Name:** SAS Superstructure**OSM Arrival Time:** 630**Prime Contractor:** American Bridge/Fluor Enterprises, a JV**OSM Departure Time:** 1530**Contractor:** Zhenhua Port Machinery Company, Ltd (ZPMC), Changxing Island **Location:** Shanghai, China**CWI Name:** Wu Ming Cai and Shazhi**CWI Present:** Yes No**Inspected CWI report:** Yes No N/A**Rod Oven in Use:** Yes No N/A**Electrode to specification:** Yes No N/A**Weld Procedures Followed:** Yes No N/A**Qualified Welders:** Yes No N/A**Verified Joint Fit-up:** Yes No N/A**Approved Drawings:** Yes No N/A**Approved WPS:** Yes No N/A**Delayed / Cancelled:** Yes No N/A**Bridge No:** 34-0006**Component:** OBG and SAS Tower Fabrication**Summary of Items Observed:**

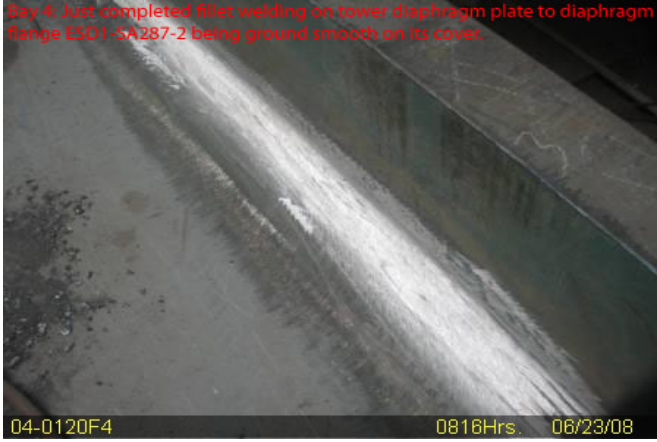
Fillet welding on tower diaphragm plate to diaphragm flange ESD1-SA287-2 was seen complete. This QA randomly observed this fillet weld has an average leg size of 22mm and throat of 15mm. ZPMC personnel still grinding/polishing this fillet cover. See photo below.

Day 4: Just completed fillet welding on lower diaphragm plate to diaphragm flange (S51-A287-2 being ground smooth on its cover.

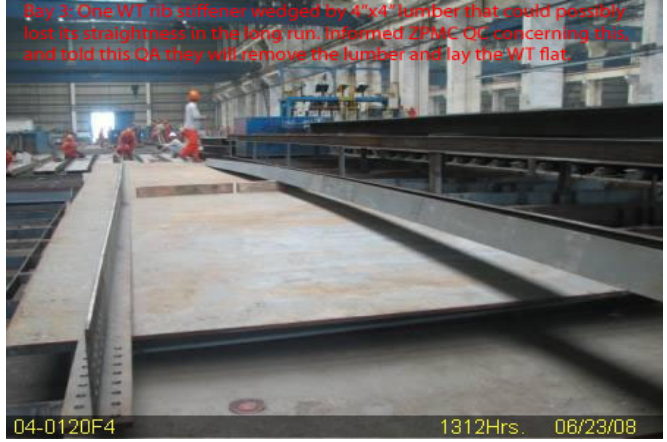
This QA also observed clamping of 3-open rib stiffener of deck panel DP048-001-001~006 to gantry #1 was on going, power wire brushing of tack welds and weld surfaces on clamped 3-open rib stiffener to deck panel DP047-001-001~006 at gantry #1 welding table. Drilling of 16-24mm diameter bolt holes on flange and 14-24mm diameter bolt holes on web of WT (W21x57) rib stiffener for various bottom panels BP196 and side panels SP173 in progress. This QA observed one WT rib stiffener wedged with 4"x4" lumber that could possibly make the stiffener lost its straightness. ZPMC QC was informed concerning this incident and QC told this QA they will remove the lumber and lay the stiffener flat. See photo below.

Day 3: One WT rib stiffener wedged by 4"x4" lumber that could possibly lost its straightness in the long run. Informed SPMC OC concerning this, and told this QA they will remove the lumber and lay the WT flat.
